EFFLORESCENCE

What is efflorescence.

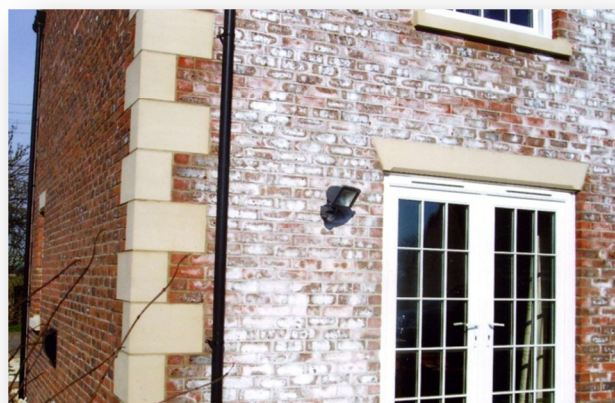
Visible as a harmless deposit of soluble material on the surface of brickwork, its texture may vary from light and fluffy to hard and glassy depending on its composition. The deposits consist of natural occurring soluble salts which vary considerably throughout the country, not only within the clays used for the manufacture of bricks but also in the constituents necessary for the production of the mortar i.e. sand and cement. Apart from the salts derived from the bricks and mortar, almost any salt can form efflorescence if it is introduced as a contamination from external sources. The quantities of salts involved are small and a tiny percentage of soluble sulfates in the bricks or the cement is sufficient to account for the amount of efflorescence usually seen.
