DISCOLOURATION OF MASONRY DUE TO SATURATION

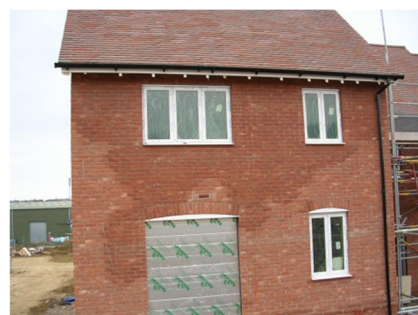
Saturation occurring prior to roof & window placement.

With brickwork, mortar takes at least a month to reach its optimum strength and hardness and the structure will need some care and consideration until then. Therefore it is likely that water can penetrate readily and saturate units whilst the building is in an unfinished state.

As with any absorbent material, **it will take time to dry out thoroughly** and this will be governed largely on the time of year construction takes place and by the amount of protection afforded during the building process.

Good site practice and protection of newly laid masonry from rainfall can minimise saturation which could also trigger efflorescence or lime leeching from mortar or concrete components.

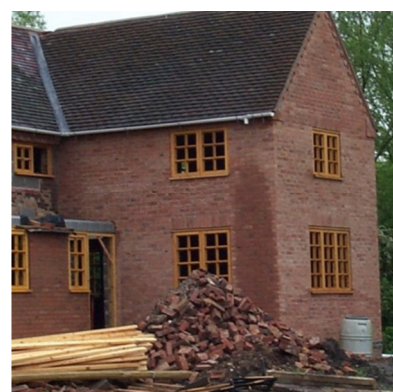
Saturation occurring where downpipes have not been installed.

During rainfall, saturation of masonry can be intensified by other components, for example rain-water outlets prior to the down-pipes being fitted or scaffolding boards adjacent to freshly constructed masonry. The after effects will be localised darkened patches.

- Turn back scaffolding boards to stop rain splashing onto brickwork.
- Hessian is not a waterproof covering.
- Protect stacks of unused materials from rainfall at all times.
- Fit gutter downpipes or temporary channels as soon as possible.
