## Site practice &amp; troubleshooting

**EXPANSIVE PARTICLES****What are expansive particles.**

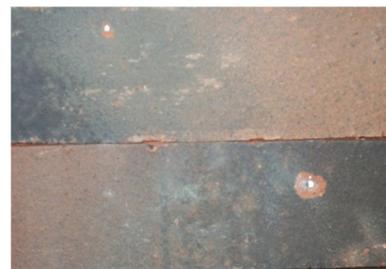
After firing, when the brick absorbs moisture, a chemical reaction takes place. The particles swell which, if close enough to the surface may cause portions of the brick face to "pop" off.

The results are small pits in the surface of the brick with a white (lime) or purple (siderite) spot in the centre.

*Expanded lime particles – noticeable on a colour sprayed surface*

The expanded particle is drilled out to provide a more substantial key for a filling material. The depression is then filled with a suitable material, such as a compound of a cementitious/resin nature, which is coloured to closely match the original brick colour and additions of various sands etc. are used to provide a similar texture.

The filler is then cured and if any further work is required to more closely resemble the brick surface this is then done. The whole surface of the brick including the filled area is then tinted to blend in with existing brickwork.
