### DISCOLOURATION OF MASONRY DUE TO SATURATION

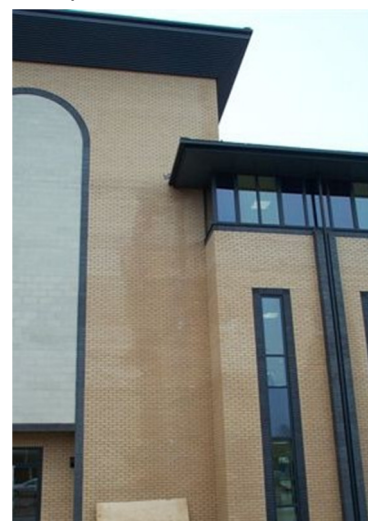
*Design detailing has caused saturation staining where water runs off roof ledges.*

Many materials used in construction are porous to a lesser or greater degree, whether it be stone, concrete, brick, mortar etc. This should be allowed for in design and detailing of buildings. Other materials such as glass, metals and plastics etc. are not absorbent and water will readily run off these components onto adjacent materials.

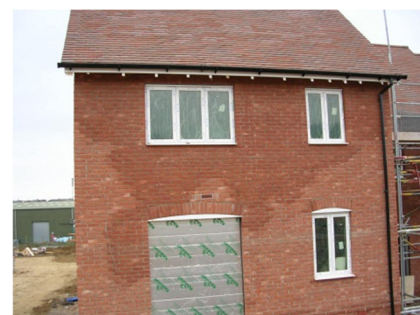
*Saturation occurring prior to roof & window placement.*

With brickwork, mortar takes at least a month to reach its optimum strength and hardness and the structure will need some care and consideration until then. Therefore it is likely that water can penetrate readily and saturate units whilst the building is in an unfinished state.

Good site practice and protection of newly laid masonry from rainfall can minimise saturation which could also trigger efflorescence or lime leeching from mortar or concrete components.

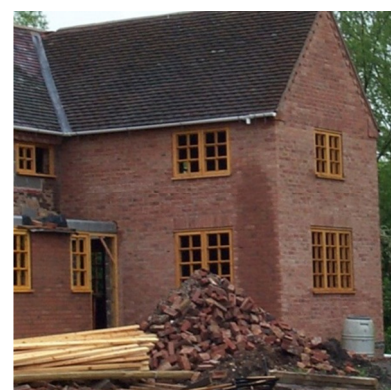
*Saturation occurring where downpipes have not been installed.*

During rainfall, saturation of masonry can be intensified by other components, for example rain-water outlets prior to the down-pipes being fitted or scaffolding boards adjacent to freshly constructed masonry. The after effects will be localised darkened patches.

- Turn back scaffolding boards to stop rain splashing onto brickwork.
- Hessian is not a waterproof covering.
- Protect stacks of unused materials from rainfall at all times.
- Fit gutter downpipes or temporary channels as soon as possible.
