Site practice & troubleshooting
VANADIUM STAINING/EFFLORESCENCE

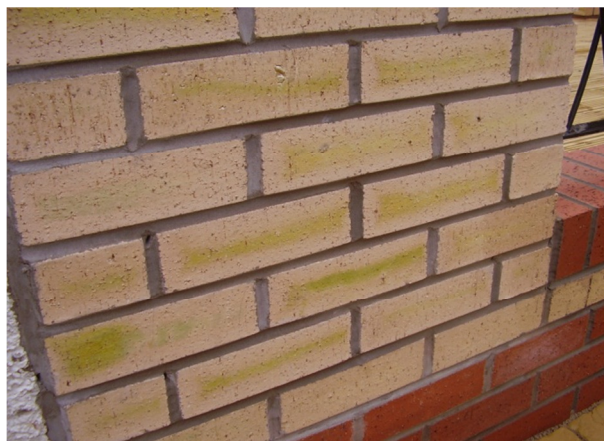
Like most soluble salts it requires saturation to bring it to the surface when it appears as a yellowish stain that may change to a greenish or even light brown colour.

Vanadium does not come and go in the same manner as a white efflorescence and should really be described as a stain.

The discoloration is only on the surface of the brick but its intensity and the speed at which it can appear during construction can be a cause of concern for the user.

Under no circumstances should a standard acidic brick cleaner be used as this may "fix" the stain and turn it brown in colour.

Once the structure is watertight, if removal of the stain is required manually, minor occurrences may be treatable by brushing on household bleach in concentrated form, when the stain is bleached apply a washing soda solution (12g/litre) and leave on the wall.

Alternatively for more persistent stains, brush on an oxalic acid solution (100g/litre) and, when the stain is bleached apply a washing soda solution (12g/litre) and leave on the wall.

'Vanatrol' is a product that is effective in removing both vanadium and cement stains without turning dark and fixing it. Ask an Ibstock Advisor for details.
